Deformation Monitoring and Exploration on Shuping Landslide Induced by Impoundment of the Three Gorges Reservoir, China

Fawu WANG, Gonghui WANG, Kyoji SASSA, Kiminori ARAIBA*, Atsuo TAKEUCHI**,
Yeming ZHANG***, Zhitao HUO***, Xuanming PENG***, Weiqun Jin***

Synopsis

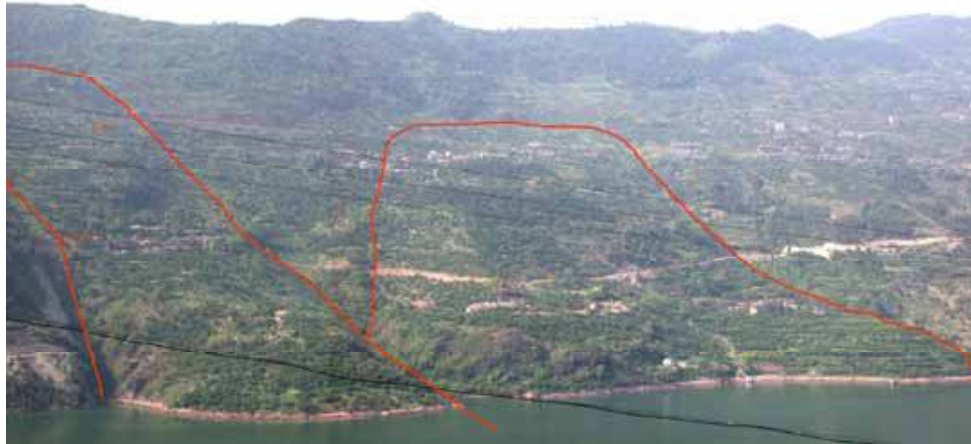
Fig. 2 Shuping landslide consisting of two blocks at the main stream of the Three Gorges Water Reservoir

For these reasons and aiming to study the influence of impoundment on landslide deformation, we selected Shuping landslide, which is located at the main stream of the Yangtze River (Fig. 1) in Shazhenxi Town, just about 3.5 km from the Qianjiangping landslide, as our research and monitoring field. Figure 2 is an oblique photograph of the Shuping landslide, and Figure 3 is the plane of the landslide. The landslide ranged its elevation from 65 m to 500 m. Its width was about 650 m, the estimated thickness of the sliding mass was 40 m to 70 m according to the bore hole data, and the total volume was estimated as $2.0 \times 10^7 \text{ m}^3$. The toe part of the landslide was under the water level of the Yangtze River. The slope is gentle at the upper part and steep at the lower part with a slope angle of 22 degrees and 35 degrees respectively..

The Shuping landslide is an old landslide which consists of two blocks. This can be confirmed in the photograph (Fig. 2). After the first impoundment of the Three Gorges water reservoir ended on June 15, 2003, obvious deformation phenomenon appeared at the slope, and it became intense from February 8, 2004. Also, the two blocks shows different deformation rate at slope surface. The serious deformation situation made 580 inhabitants and 163 houses in danger directly, and all of the inhabitants were asked to live in the disaster prevention tents which were provided by the central government. Until May 2004, most inhabitants moved their houses out of the landslide area.

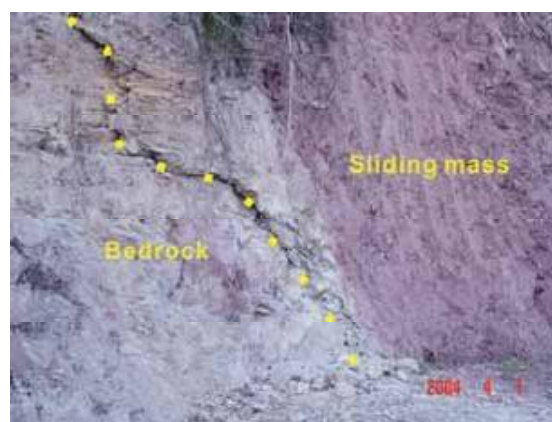
Figure 4 shows a crack at the right boundary of Block-1 outcropped at a local road. The right-hand side is the sliding mass consisting of red muddy debris of old landslide, and the left hand side is bedrock of sandy mudstone, muddy siltstone of Badong formation of Triassic period (T3b).

Figure 4 Deformation situation at the right boundary of Block-I outcropped at a roadside

Figure 8 shows the extensometer installed in Shuping landslide. The positions of all of the thirteen extensometers were shown in Figure 3 as “SP1-x”. Among them, SP1-1 and SP1-2 were set across the main scarp; from SP1-3 to SP1-6 were set below the Shahuang road which has a high traffic. SP1-7 and SP1-8 were set almost parallel with SP1-5 and SP1-6. SP1-9 was set at the low part. Then, SP1-10, SP1-11, and SP1-12 were set near the Yangtze River at the toe part of the landslide. SP1-13 was set at the right boundary of Block-1 shown in Figure 4, because the crack extension is obvious.

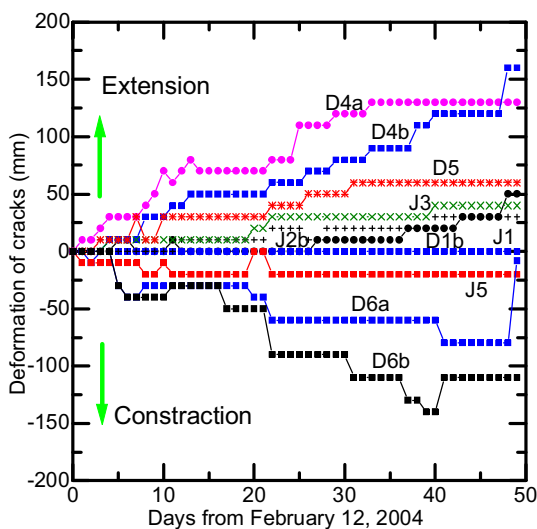
Figure 6 Measured results of crack deformation in Block-I

Because of the serious deformation situation, local government decided to monitor the cracks distributing in the slope from February 12, 2004. The inhabitants were asked to measure the width change of the cracks near their houses (see Fig. 3). For measurement, two small piles were set across a crack, and the distance between the two piles was measured three times one day. Figure 6 shows a part of the measured results of the cracks. However, because the inhabitants are moving out of this area, the measurement points are decreasing gradually. Roughly, the measurement results of the crack deformation shows that the extension behavior occurred at the boundary and inside landslide, and constriction

deformation occurred at the other parts in the landslide block. For the 50 days period from February 24, 2004, the maximum displacement including extension and contraction respectively reached about 140 mm, showing an active deformation.

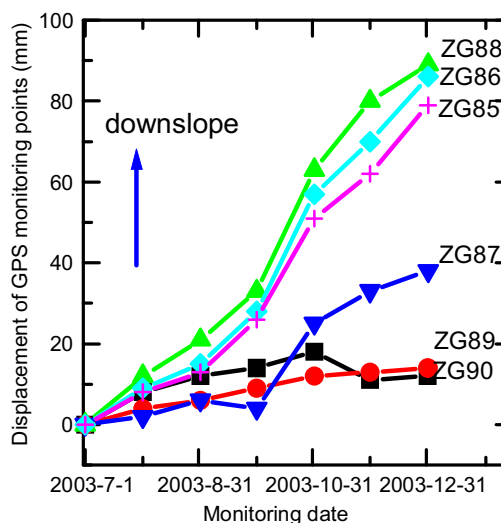
Figure 7 shows the monitored results of the GPS monitoring at the first six months after the impoundment. The displacement rate of Block-I increased rapidly after October 2003, and other two tendencies are also very clear. (1) The displacement at the lower part is larger than that at the upper part, this may be caused by water buoyant of the impoundment of the reservoir; (2) The displacement of Block-I is more active than Block-II, showing that the two blocks are independent from each other.

Figure 7 GPS monitored results along the central section lines of Block-I and Block-II

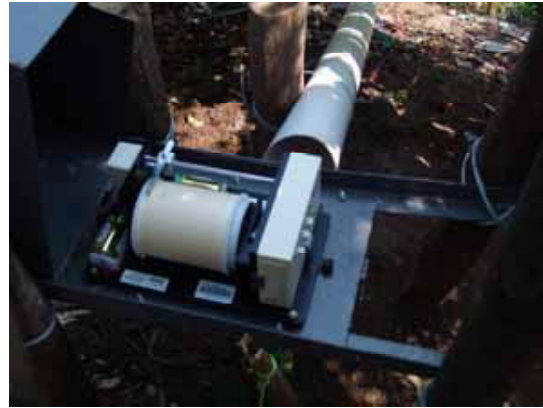
Figure 8 Extensometer installed in Shuping landslide
The deformation is recorded on the rolled paper (left) and also saved in a memory (right box)

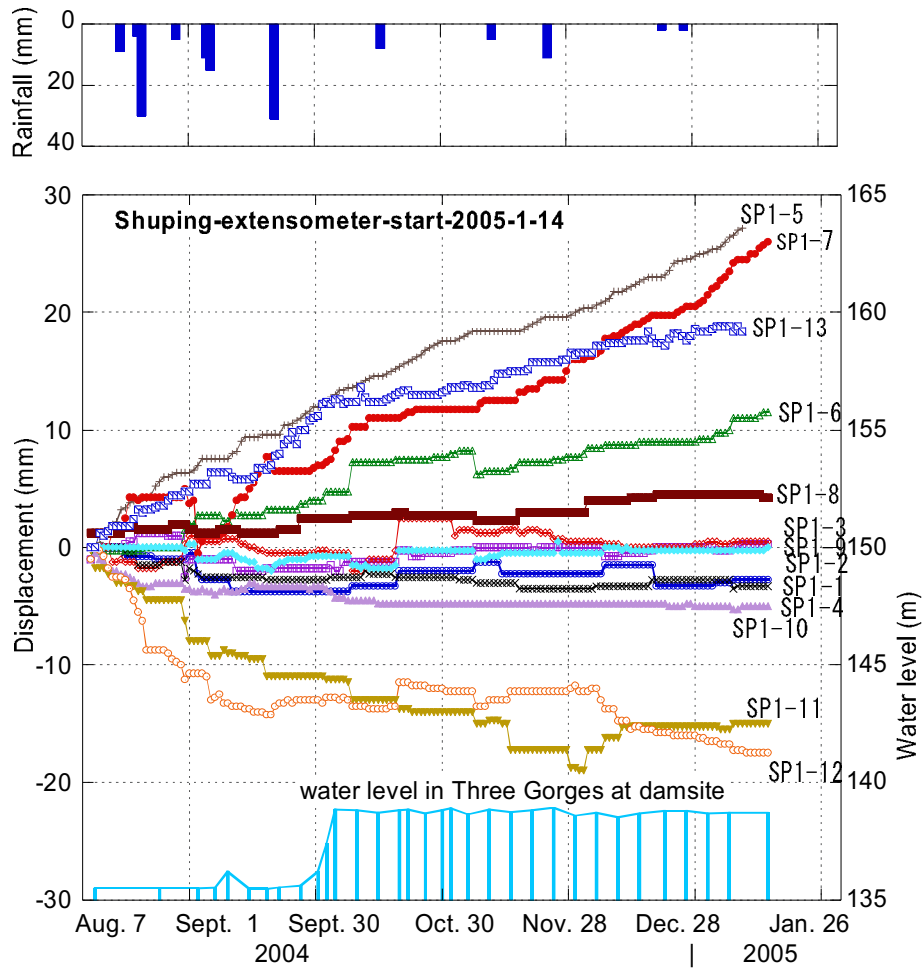
Figure 9 Monitored results of the extensometers (middle), the precipitation data in Yichang City (top) and water level in the Three Gorges Dam site (bottom)

Figure 9 is the monitoring results of all the thirteen extensometers, accompanying with the water level in the Three Gorges at dam site showing at the bottom, and the rainfall records of this area showing at the top.

The monitoring results show some tendencies of the landslide displacement. (1) The SP1-1 and SP1-2 at the main scarp did not record obvious displacement. One possible reason is that the setting positions of the two extensometers did not cross the main scarp. (2) The deformations at SP1-5, SP1-6, SP1-7 and SP1-8 are the most active ones. (3) The toe part of the landslide shows compression behavior. Comparing with the largest displacement at the lower part by GPS monitoring in the first six months after the first impoundment, it may estimate that the toe part moved down faster at the first

period and became silent now; the upper part moved slowly at the first stage, and now followed the movement of the lower part and compressed the lower part. An exact examination will be conducted with the comparison of the recent GPS monitoring data along the central longitudinal section, which is not open in this period.

Another important tendency was recorded in the monitoring results. In mid-September, the water level of the Three Gorges was raised for about 3 m, corresponding to this water level raising, the displacement velocity of SP1-5, SP1-6 and SP1-7 increased obviously, reflecting the influence of the impoundment on the slope deformation.

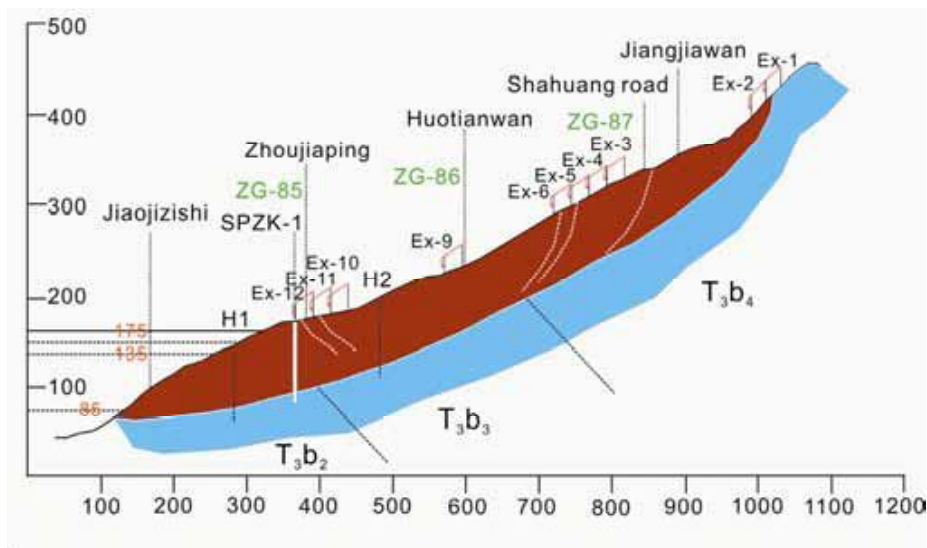
Figure 13 Longitudinal section of the Shuping landslide

Through the GPS monitoring, crack displacement measurements, extensometer monitoring along the longitudinal section of Block-1, the deformation style of the Block-1 of Shuping landslide can be sketched as Figure 13. Sooner after the impoundment of the water reservoir, the toe part displaced downward faster than the upper part. In the current stage, one and half years after the first impoundment, the slope deformation style changed. The displacement of the lower part almost terminated while the upper part displaced downward gradually, and compressed the toe part.
